Manhole Inspection Summary

Manhole # S47K__015MH

Insp Date: **7/28/08 1:16 PM**

Location Address: **2300 leakin st**

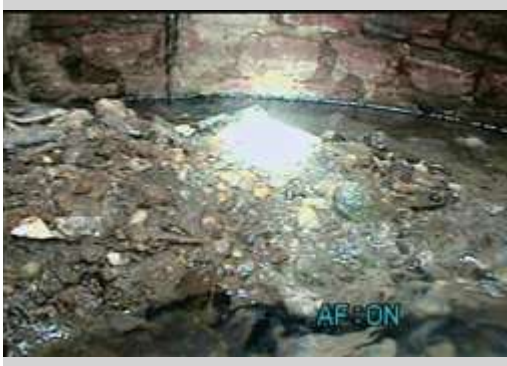
Defect 5

Condition: ☐ Sound ☐ Cracked ☐ Root Intrusion ☐ Deteriorated ☐ Leaks ☒ **Debris**

bench debris

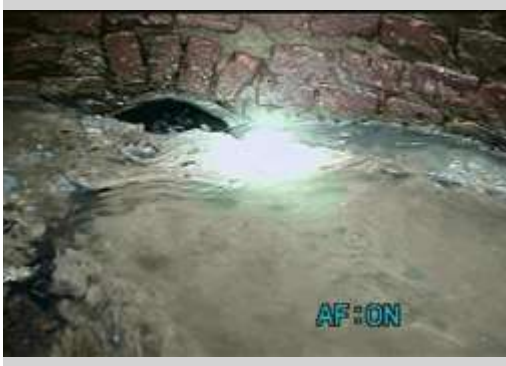
Defect 4

Condition: ☐ Sound ☐ Cracked ☐ Root Intrusion ☐ Deteriorated ☐ Leaks ☒ **Debris**

channel debris

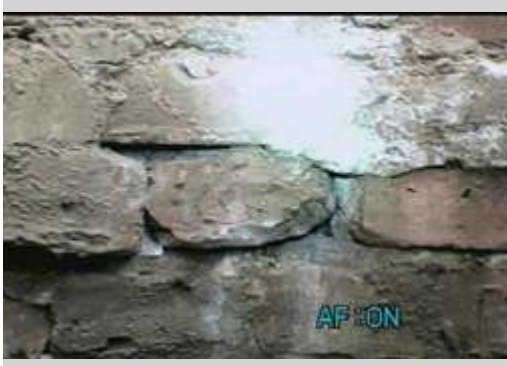
Defect 3

Condition: ☐ Sound ☐ Cracked ☐ Root Intrusion ☒ **Loose Brick** ☐ Deteriorated

corbel loose bricks

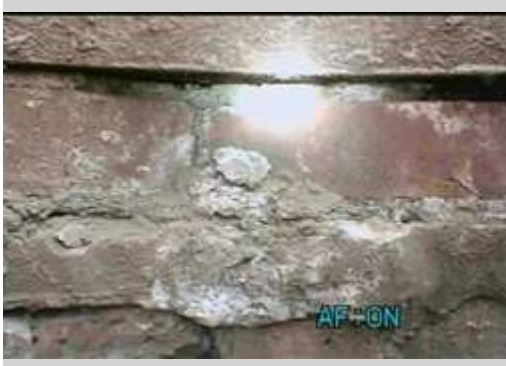
Defect 2

Condition: ☐ Sound ☐ Cracked ☐ Root Intrusion ☐ Loose Brick ☒ **Deteriorated**

Chimney deteriorated, frame adj

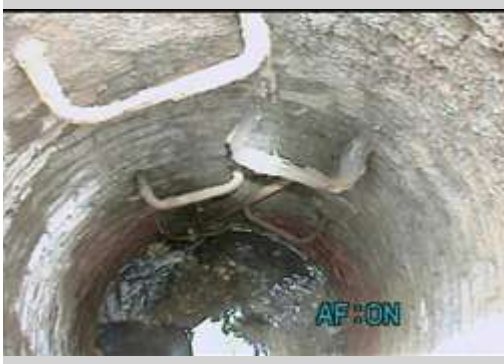
Defect 1

Count: **5** Missing: **0** ☒ **Corroded**

steps

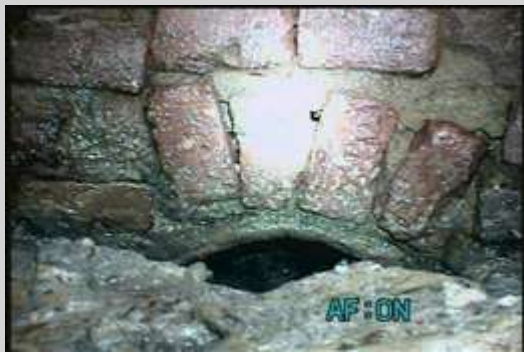
12 O'Clock Outflow

Deposits: ☐ None ☐ Mud ☐ Sludge ☒ **Debris** ☐ Grease

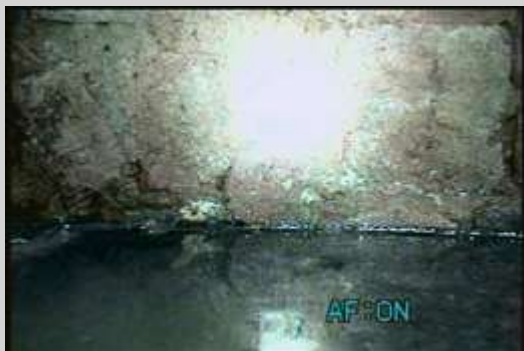
3 O'Clock Inflow

Comments **aaa Pipe at 3 is under water**

under water
